ARKANSAS  
Department of Environmental Quality

SUBJECT: Diaz Intermediates Corporation  
301 Wyanoke Drive  
West Memphis, Arkansas 72301

## MEMORANDUM

SUBJECT: Diaz Intermediates Corporation  
ARR000005843  
AFIN 18-00401

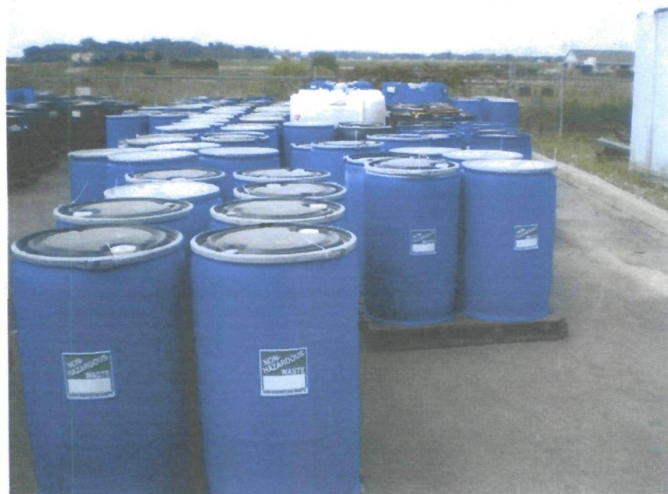
Even though there are numerous containers of different type materials on-site, we only observed one (1) 55-gallon container that had leaked. (Refer to Attachment #4, Photographs #52 and #53.) This container was labeled Bromobenzene and the area where the leak occurred is now covered with a crystal-like substance.

NOTE: One (1) 55-gallon poly drum of Bromobenzene was found to be leaking at the bottom of the drum with a crystal-like material at the leak.

<b>Location:</b>		Diaz Intermediates Corp., 301 Wyanoke Rd., West Memphis, AR 72301						
<b>Photographer:</b>		Les Branscum, ADEQ			<b>Witness:</b>		Penny Wilson, ADEQ	
<b>Photo #</b>	52	<b>Of</b>	67		<b>Date:</b>	28 AUG 07	<b>Time:</b>	1434
<b>Description:</b>		Leaking drum on right side of drums in photo 51.

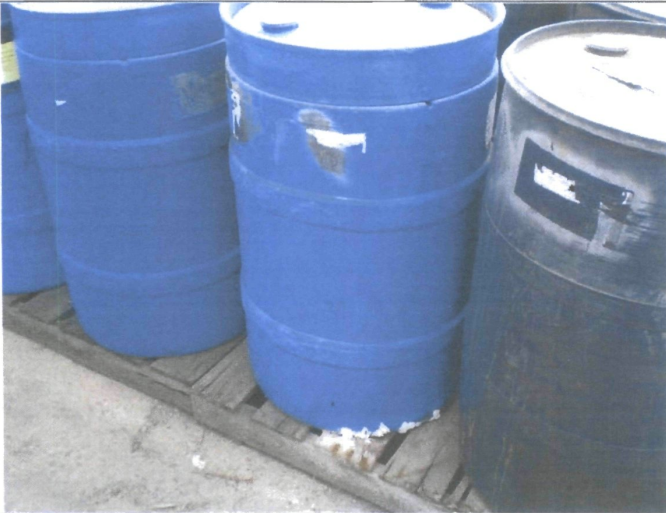
<b>Photographer:</b>		Les Branscum, ADEQ			<b>Witness:</b>		Penny Wilson, ADEQ	
<b>Photo #</b>	53	<b>Of</b>	67		<b>Date:</b>	28 AUG 07	<b>Time:</b>	1434
<b>Description:</b>		Close up of leaking drum showing salt like crystals that have formed around the damaged base of the drum. The leaking material had solidified by the time of the photo, no liquid was seen.

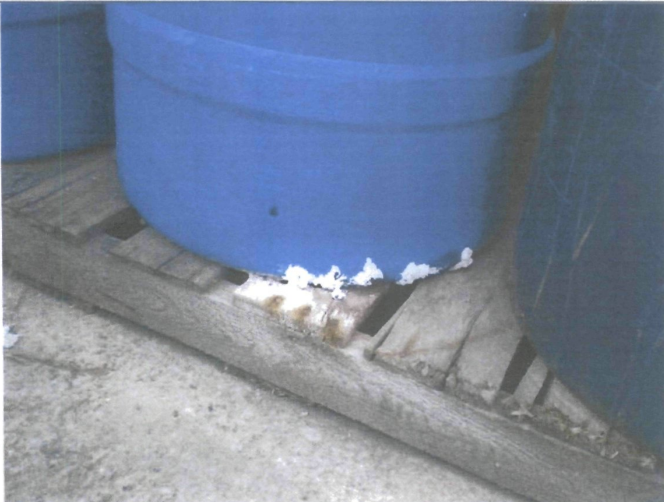
<b>Location:</b>	Diaz Intermediates Corp., 301 Wyanoke Rd., West Memphis, AR 72301							
<b>Photographer:</b>	Les Branscum, ADEQ				<b>Witness:</b>	Penny Wilson, ADEQ		
<b>Photo #</b>	54	<b>Of</b>	67		<b>Date:</b>	28 AUG 07	<b>Time:</b>	1437
<b>Description:</b>	Close up of label on damaged drum. Label indicates contents are 'Bromobenzene (Z) with high DBB/TBB'.

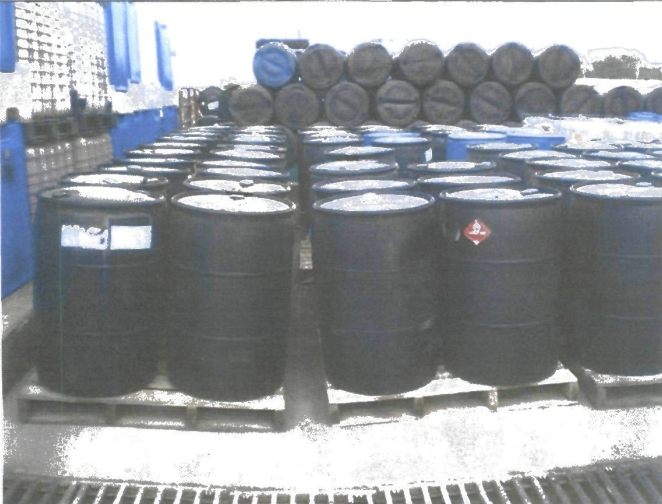
<b>Location:</b>	Diaz Intermediates Corp., 301 Wyanoke Rd., West Memphis, AR 72301						
<b>Photographer:</b>	Les Branscum, ADEQ				<b>Witness:</b>	Penny Wilson, ADEQ	
<b>Photo #</b>	56	<b>Of</b>	67		<b>Date:</b>	28 AUG 07	<b>Time:</b> 1439
<b>Description:</b>	Continuation of drums in photo 55, facing east. Process Building is to the right in background.

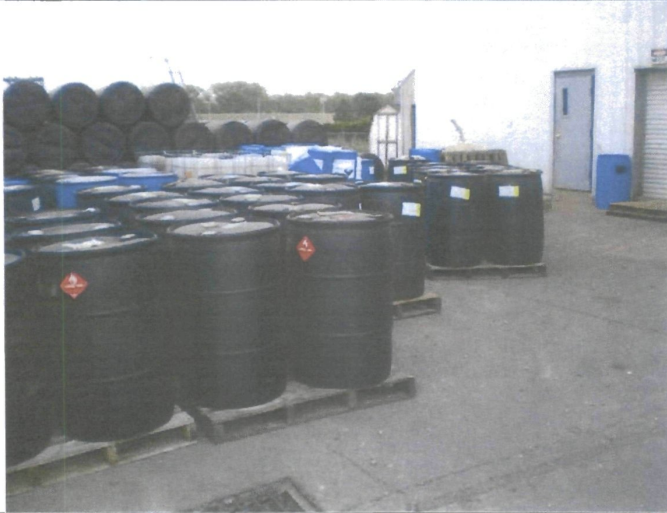
<b>Photographer:</b>	Les Branscum, ADEQ				<b>Witness:</b>	Penny Wilson, ADEQ	
<b>Photo #</b>	57	<b>Of</b>	67		<b>Date:</b>	28 AUG 07	<b>Time:</b> 1443
<b>Description:</b>	Drums on Bulk Truck Pad, facing south. Process Building is to the left.

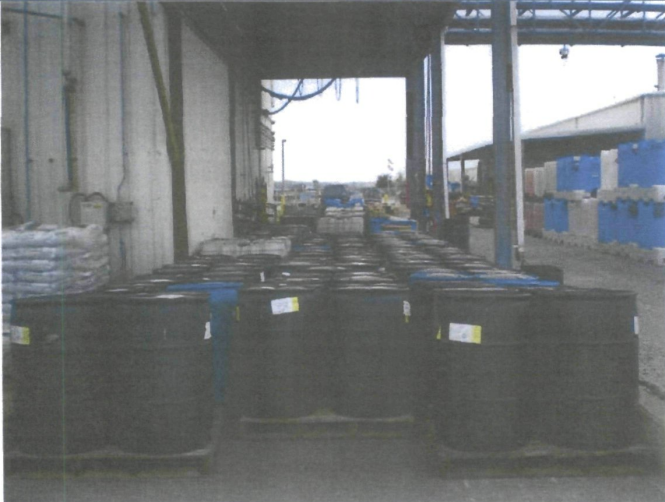
<b>Location:</b>	Diaz Intermediates Corp., 301 Wyanoke Rd., West Memphis, AR 72301							
<b>Photographer:</b>	Les Branscum, ADEQ				<b>Witness:</b>	Penny Wilson, ADEQ		
<b>Photo #</b>	58	<b>Of</b>	67		<b>Date:</b>	28 AUG 07	<b>Time:</b>	1448
<b>Description:</b>	Drum labeled 'Hydrobromic Acid' at south end of Bulk Truck Pad.

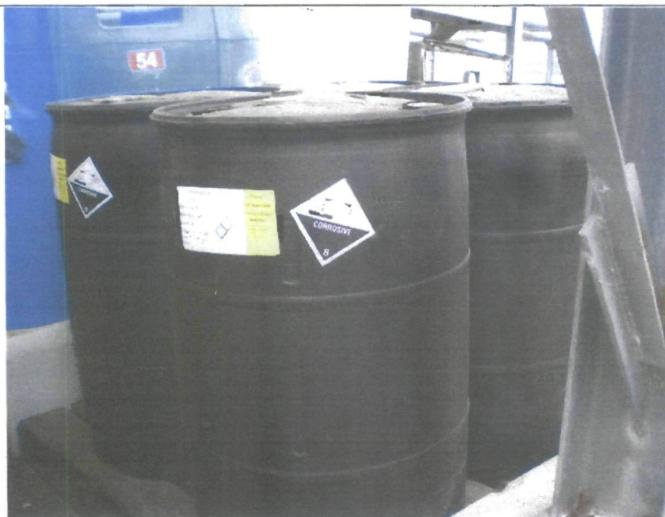
<b>Photographer:</b>	Les Branscum, ADEQ				<b>Witness:</b>	Penny Wilson, ADEQ		
<b>Photo #</b>	59	<b>Of</b>	67		<b>Date:</b>	28 AUG 07	<b>Time:</b>	1448
<b>Description:</b>	Close up of drum in photo 58 showing date of 7-19-05.

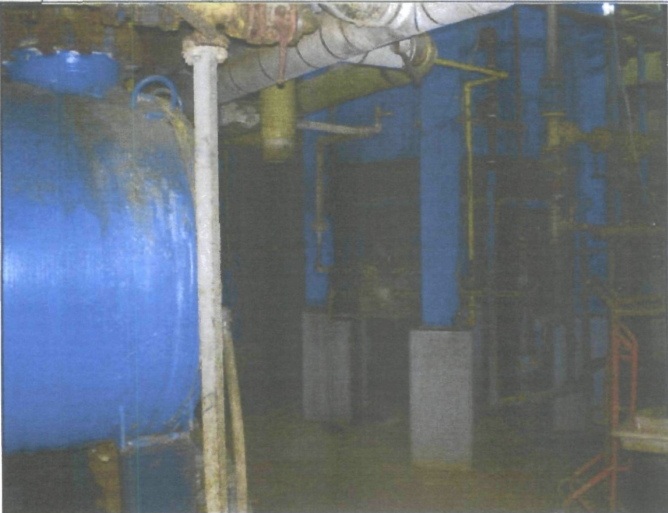
<b>Photographer:</b>	Les Branscum, ADEQ				<b>Witness:</b>	Penny Wilson, ADEQ	
<b>Photo #</b>	63	<b>Of</b>	67		<b>Date:</b>	28 AUG 07	<b>Time:</b> 1500
<b>Description:</b>	Facing south inside Process Building, west side. Tank in foreground has approx. 7600 kilos of Liquid Bromine since Jan 07.

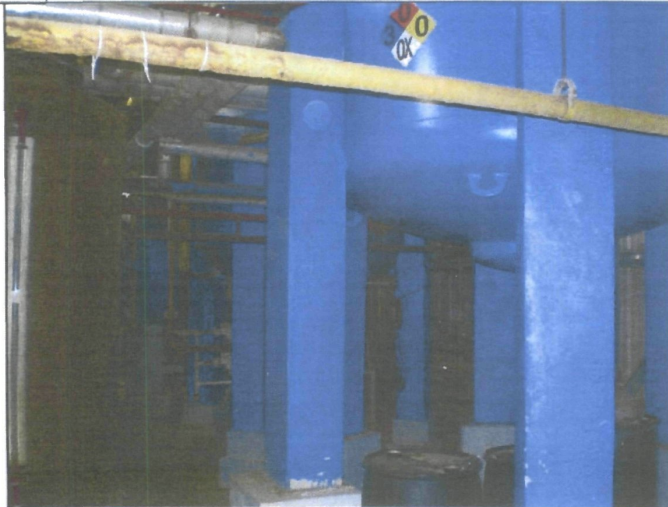
<b>Location:</b>		Diaz Intermediates Corp., 301 Wyanoke Rd., West Memphis, AR 72301						
<b>Photographer:</b>		Les Branscum, ADEQ			<b>Witness:</b>		Penny Wilson, ADEQ	
<b>Photo #</b>	64	<b>Of</b>	67		<b>Date:</b>		<b>Time:</b>	1506
<b>Description:</b>		Second floor of Process Building showing a Decanter with liquid still inside. Several were in this condition.

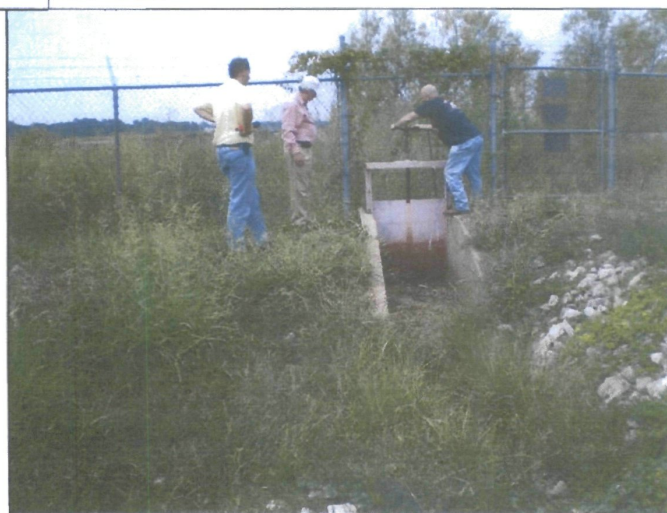
<b>Location:</b>	Diaz Intermediates Corp., 301 Wyanoke Rd., West Memphis, AR 72301						
<b>Photographer:</b>	Les Branscum, ADEQ				<b>Witness:</b>	Penny Wilson, ADEQ	
<b>Photo #</b>	66	<b>Of</b>	67		<b>Date:</b>	28 AUG 07	<b>Time:</b> 1537
<b>Description:</b>	Storm drain gate almost closed but had to be hammered the last inch.

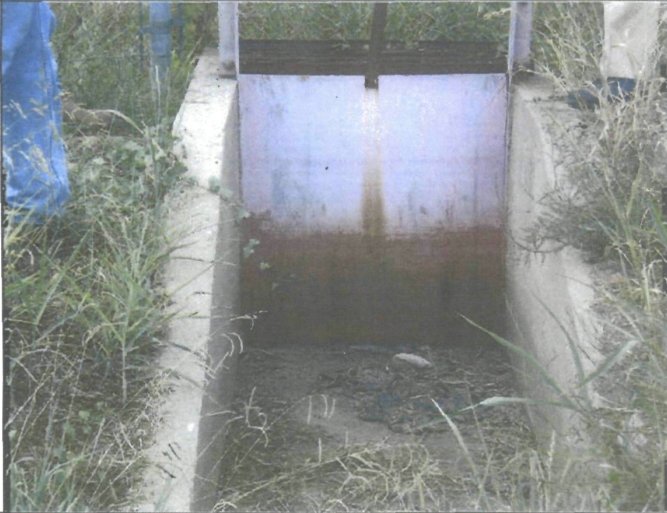
<b>Photographer:</b>	Les Branscum, ADEQ				<b>Witness:</b>	Penny Wilson, ADEQ	
<b>Photo #</b>	67	<b>Of</b>	67		<b>Date:</b>	28 AUG 07	<b>Time:</b> 1550
<b>Description:</b>	Storm drain fully closed with dirt pushed against it to help seal.
